**APOLLO 15 MISSION
ANOMALY REPORT NO. 1
MAIN PARACHUTE FAILURE**

APOLLO 15 MISSION

MAIN PARACHUTE FAILURE

Anomaly Report No. 1

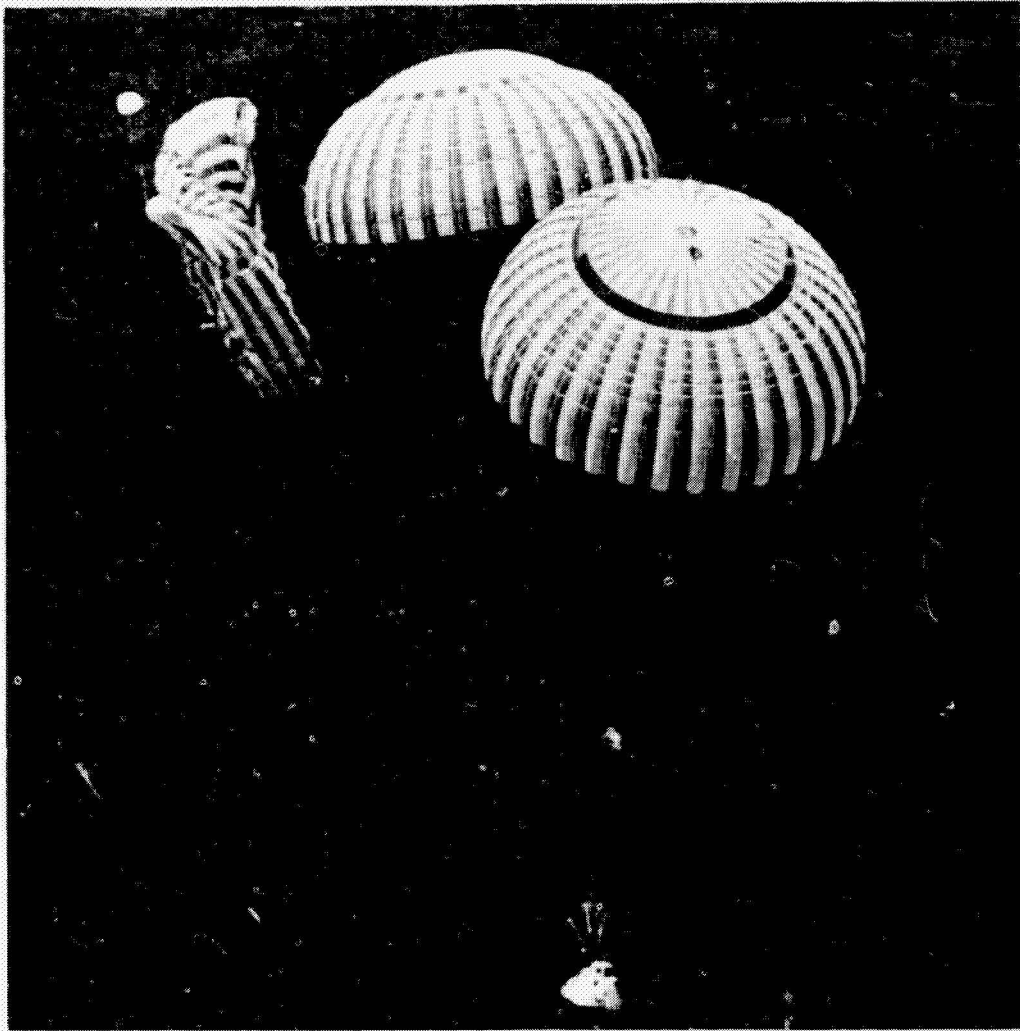
The three main parachutes of the Apollo 15 spacecraft deployed and inflated properly at approximately 10 000 feet altitude. Films show that all three parachutes disreefed and opened fully in the proper sequence. The spacecraft and its parachutes were obscured by clouds at about 7000 feet altitude. Upon emerging from the clouds at about 6000 feet altitude, one of the three main parachutes was deflated as shown in figure 1. The spacecraft and parachute system descended in this configuration to water landing. The three parachutes were disconnected and one of the good main parachutes was recovered. The failure occurred abruptly. At about the altitude and time of the failure, the forward heat shield was in close proximity to the spacecraft and the reaction control system propellant depletion firing was about completed. An inspection of the recovered parachute showed one of the six riser links had a broken stud and three others had cracks. The investigation of the failure was, therefore, focused on the reaction control system propellant depletion firing, the forward heat shield, and the failed links.

Figure 1.- Spacecraft descending with one main parachute failed.

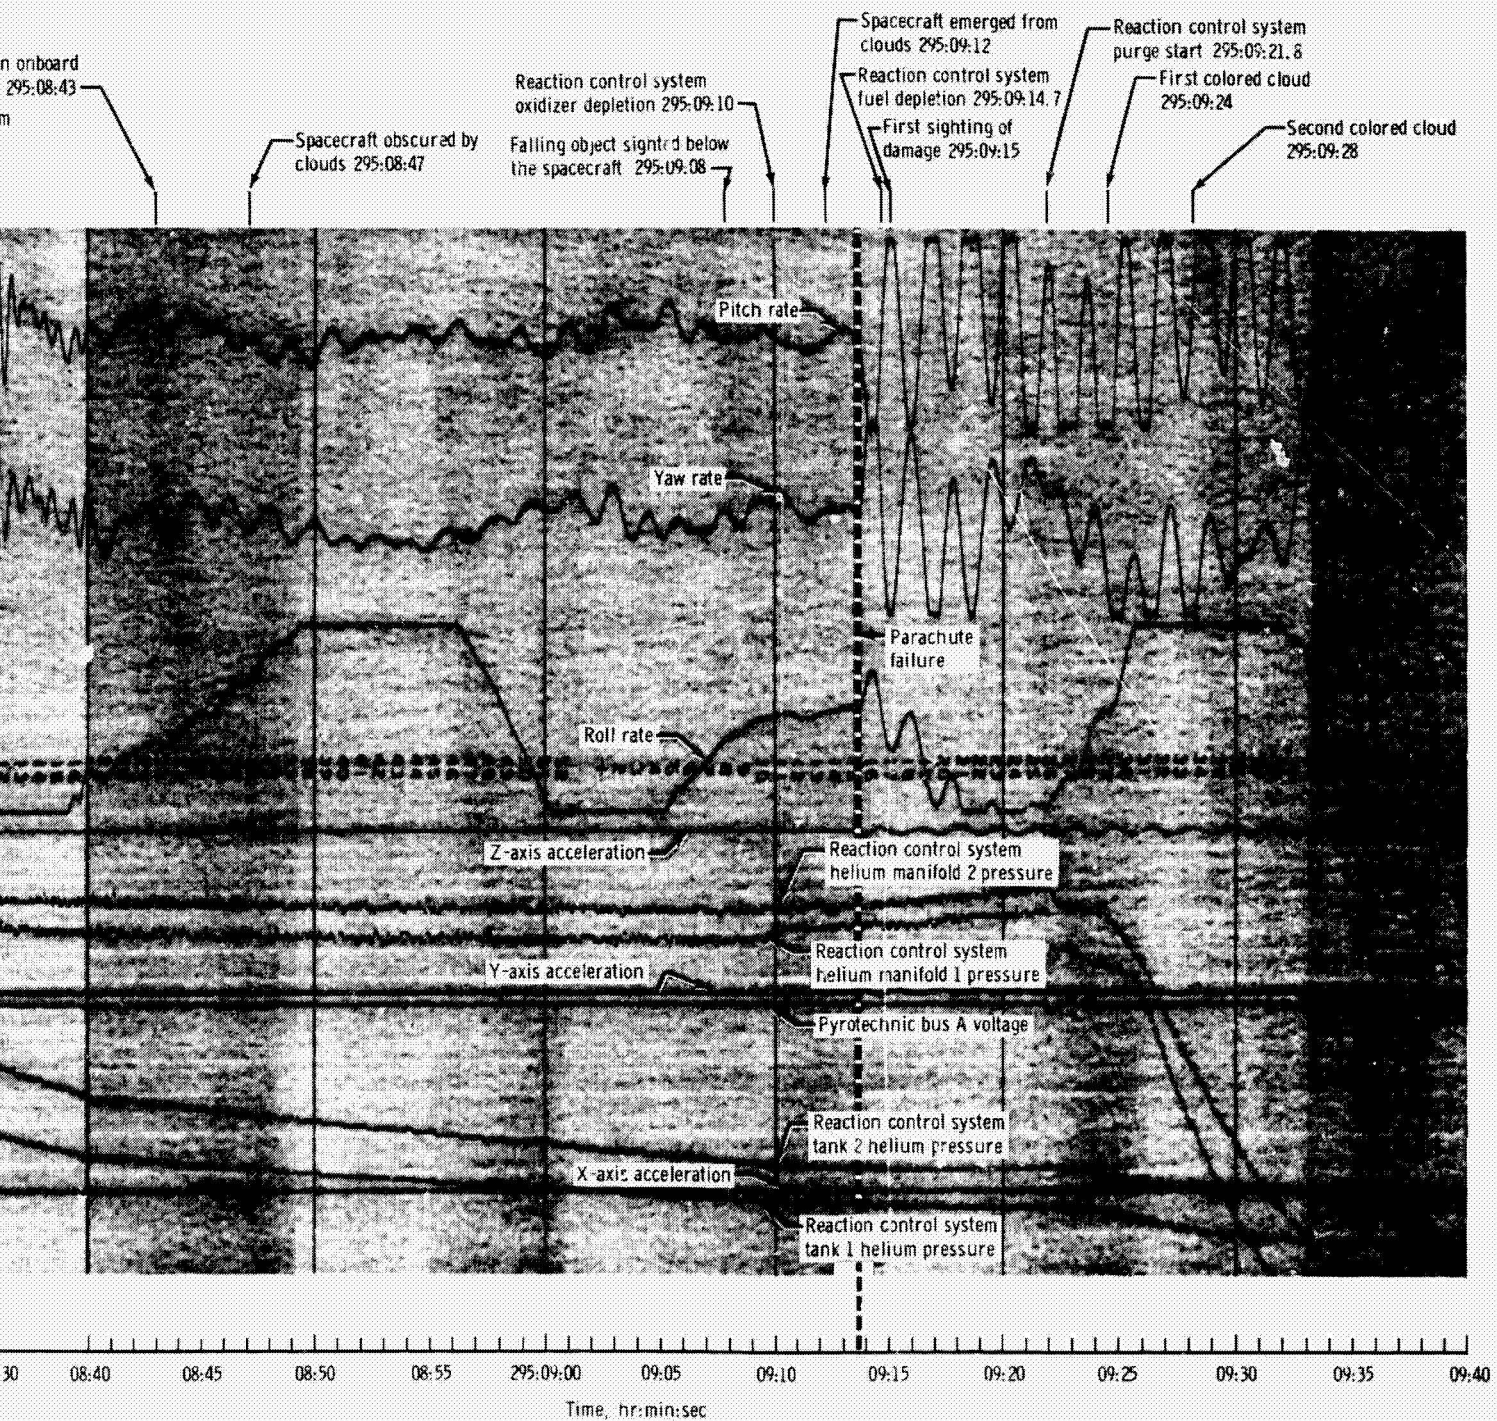
Pertinent data and the sequence of events are shown in figure 3. The data showed no abnormal conditions or events prior to the failure. About 3.5 seconds before the failure, the reaction control system manifold pressure abruptly increased to a new level, indicating the regulator had closed because all the oxidizer was expelled from the tanks. The fuel, however, was still being expelled and was calculated to have been depleted about 4.7 seconds after the oxidizer depletion. This was based on a determination of about 7 pounds of fuel remaining at oxidizer depletion. About 8 seconds after the failure, the reaction control system purge was initiated by the crew. (The crew was unaware of the failure until some time after the purge.) The time of the purge is indicated in figure 3 by the abrupt decrease in system pressure.

Figure 3.- Sequence of events during descent on the main parachutes.

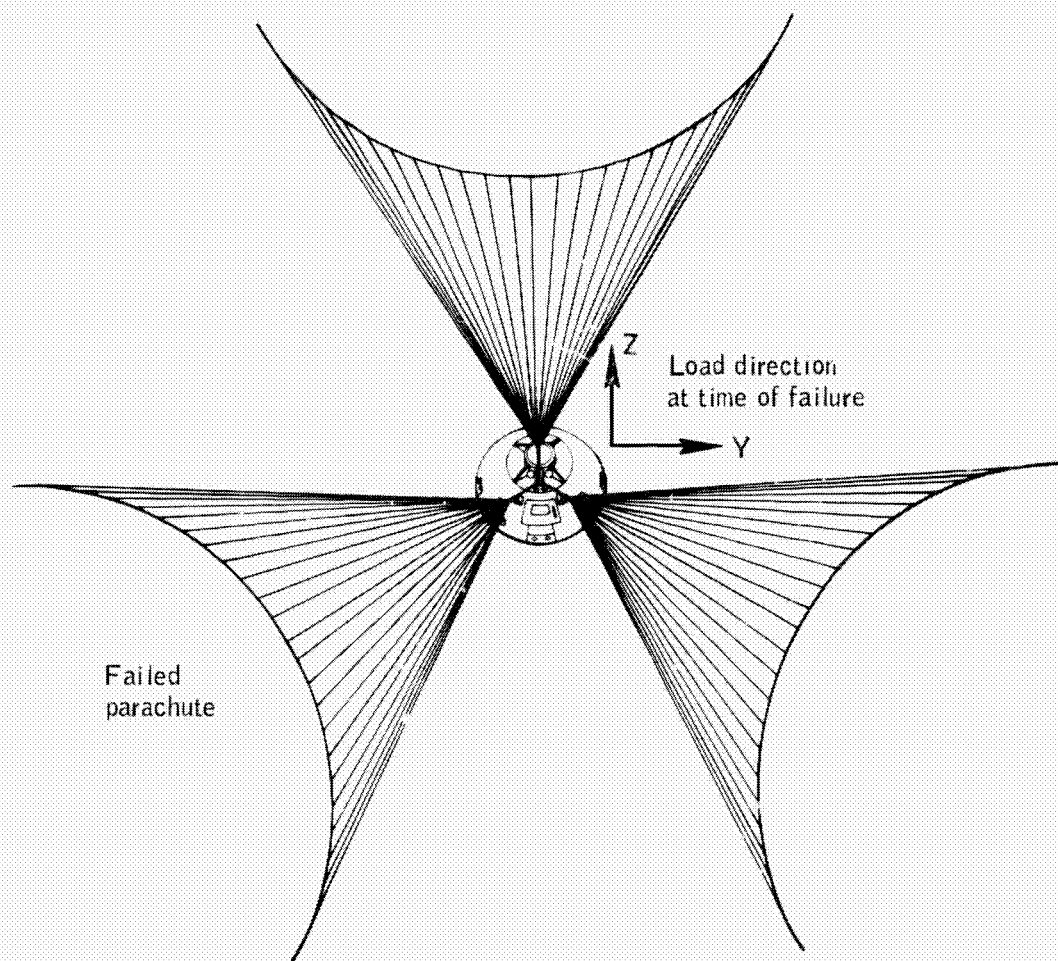
This resultant vector locates the failed parachute as shown in figure 4. The computed force vector was substantiated by body-mounted rate gyro data.

Figure 4.- Parachute location at time of failure.

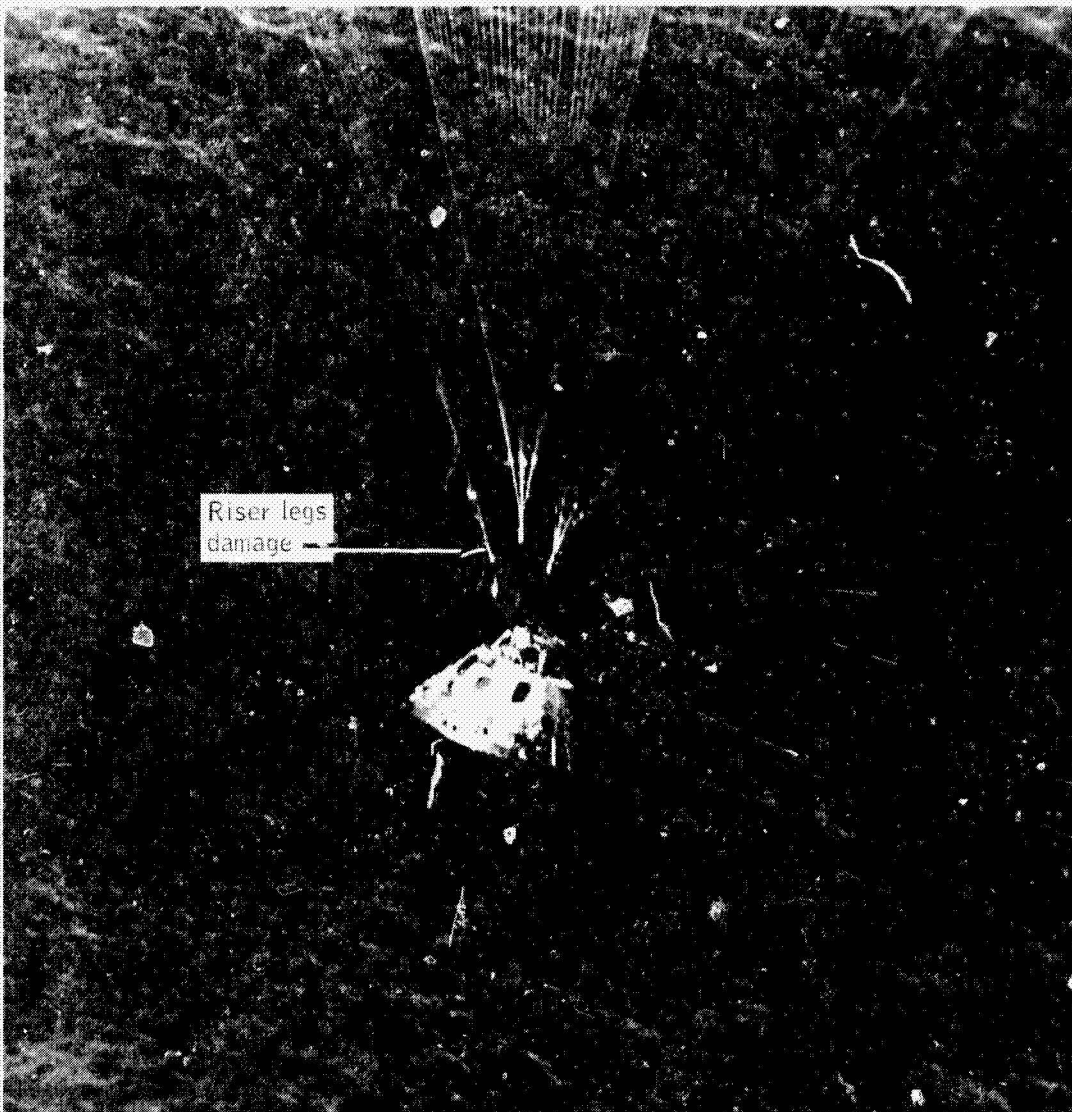
Figure 5.- Parachute riser damage during final descent.

- a. Apparently three of the six legs of the fabric riser were taking the load.
- b. There was no significant canopy damage observed.
- c. About two-thirds of the suspension lines appeared to be missing.

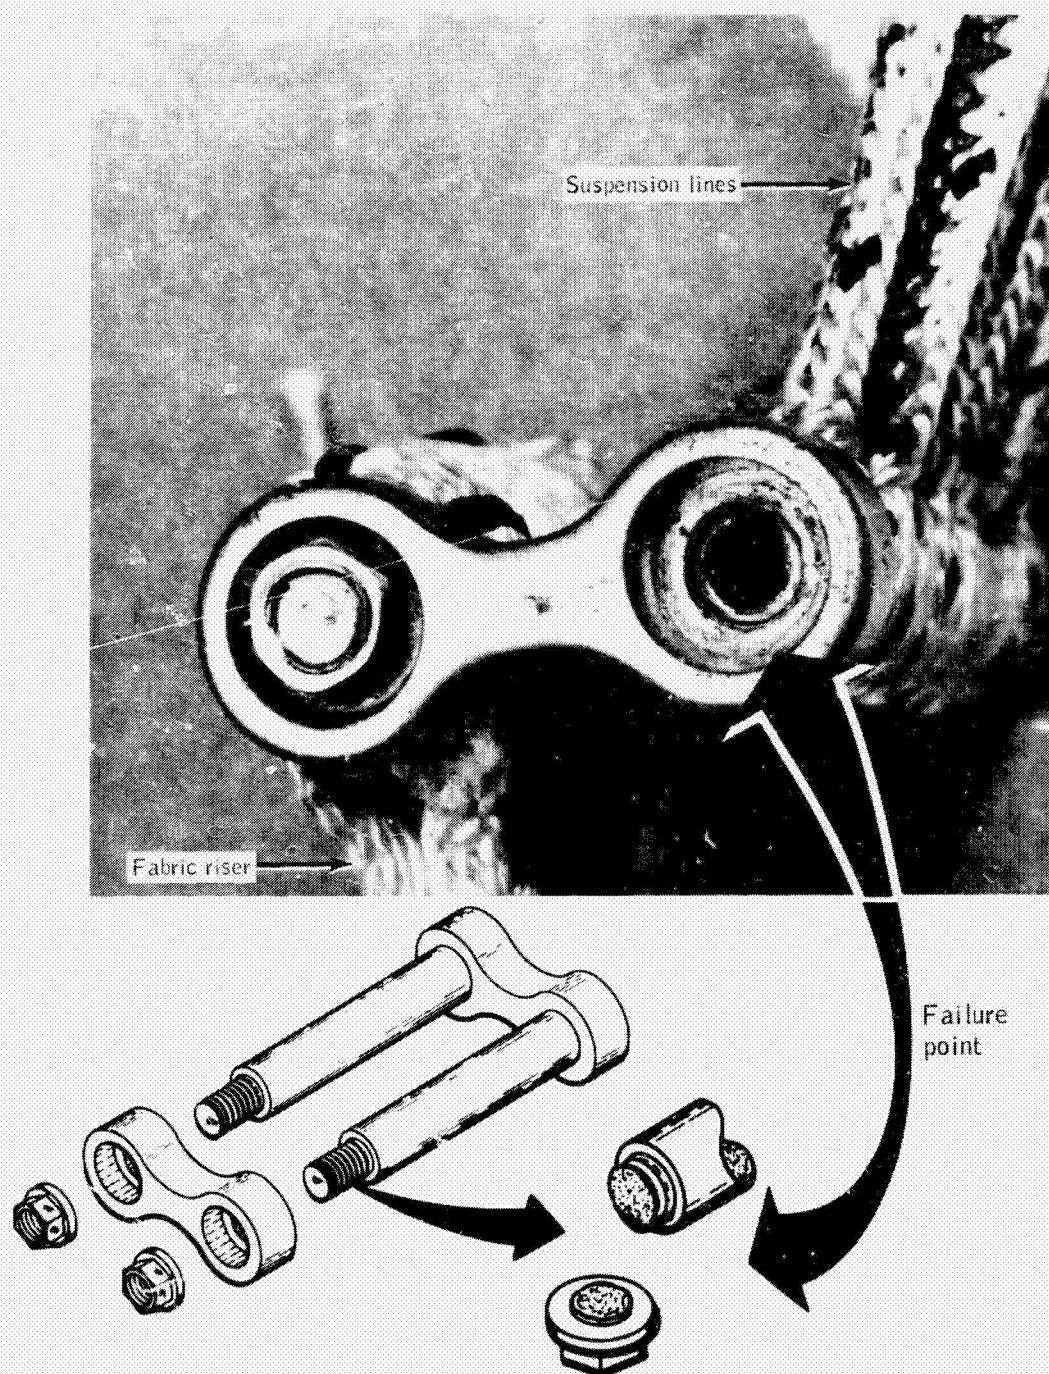
- f. The canopy was stained with oil and grease.
- g. A broken riser/suspension-line connector link was found after the protective Dacron bootie had been removed (fig. 7).

Figure 7.- Main parachute connector link failure.

One stud in a connector link assembly on the Apollo 15 recovered parachute failed. The failure was caused by stress corrosion cracking, hydrogen embrittlement, or some unknown mechanism. Stress corrosion is a possible cause because the high-strength steel (4130) used in the links is susceptible at high stress levels to cracking in salt water. Hydrogen embrittlement is a possibility because of the susceptibility of the high-strength steel to cracking from dissolved hydrogen. Earlier in the Apollo program, studs which were not properly processed after plating failed because of hydrogen embrittlement.

e. The flaw observed in the recovered parachute connector link probably occurred after the plating operation, and could be due either to salt-water-induced stress corrosion or hydrogen embrittlement.

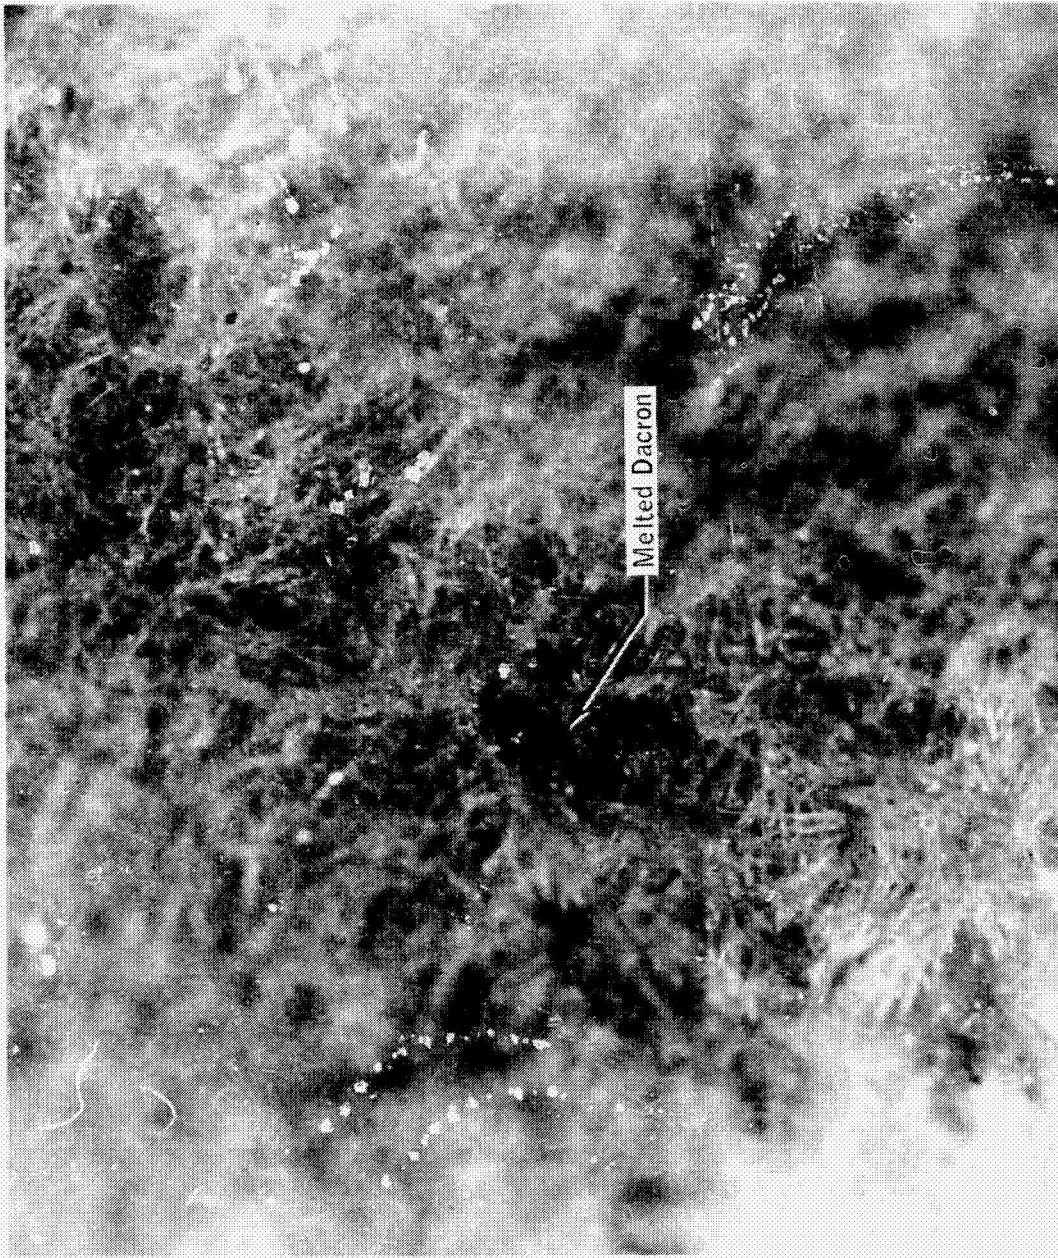
- h. Evidence of high temperature was noted on the Dacron riser protective cover (fig. 8) and the Dacron connector link bootie.

Figure 8. - Magnified view of Apollo 15 Dacron riser protective cover.

d. Evidence of melting was found on the Dacron protective covering of the fabric riser and the connector links on the recovered parachute assembly.

Corrective actions for the reaction control system include landing with the propellants onboard for a normal landing and biasing the propellant load to provide a slight excess of oxidizer. Thus, for the low-altitude abort land landing case, burning the propellants while on the parachutes will subject the parachutes to some acceptable oxidizer damage but will eliminate the dangerous burning fuel condition. In addition, the time delay which inhibits the rapid propellant dump is being changed from 42 to 61 seconds. This will provide more assurance that the propellant will not have to be burned through the reaction control system engines in the event of a land landing.

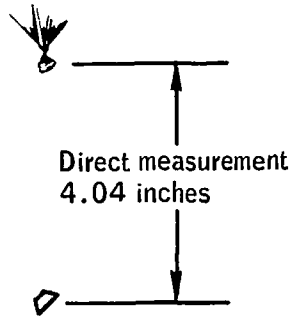
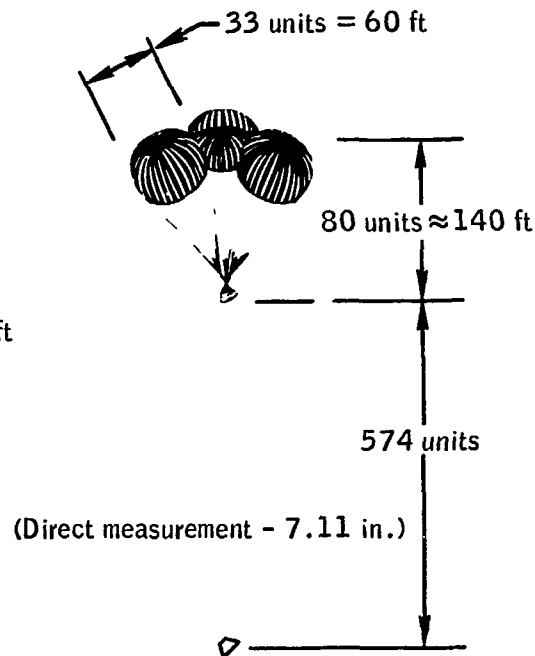
Photographic analysis.- A close examination of the television record of spacecraft descent on the main parachutes establishes that the forward heat shield was below the spacecraft at the time of the failure. Specifically, the forward heat shield is seen below the spacecraft in frame 588 (fig. 9) at 295:09:11.3, approximately 2 seconds before the anomaly occurred. By correlation with frame 775, which shows the parachute and forward heat shield in the same frame at 295:09:17.5, and by direct measurement of the separation distance between the two objects and measurement of the known parachute dimensions, the vertical separation distances between the forward heat shield and the spacecraft were 580 feet for frame 588 and 1020 feet for frame 775.

Figure 9.- Television frame and trajectory analysis.

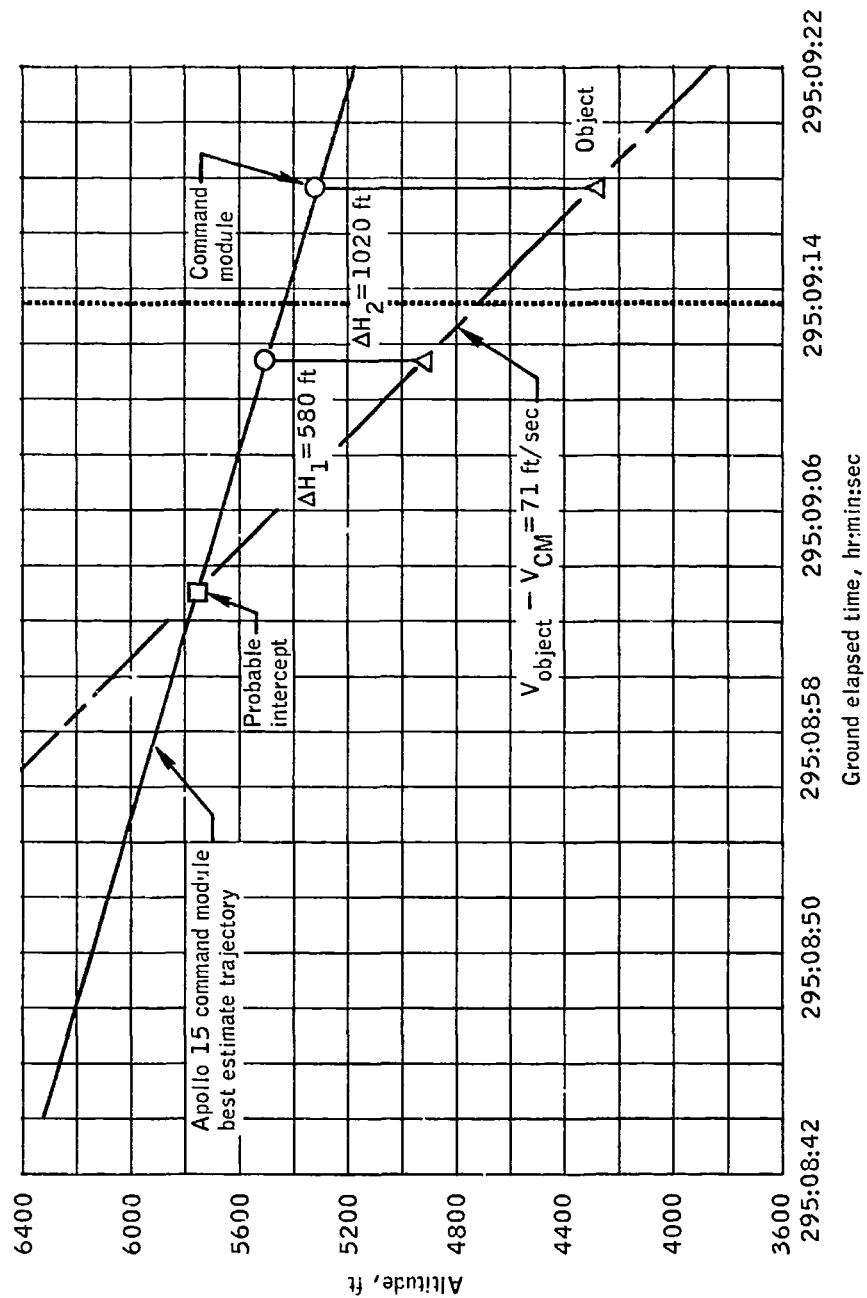
The position of the forward heat shield relative to the guidance-and-navigation-estimated trajectory is shown in figure 10. By extrapolating the forward heat shield trajectory, the forward heat shield would have intercepted the spacecraft at 295:09:03. This is 10.5 seconds before the spacecraft data indicate the anomaly occurred.

Figure 10.- Position of forward heat shield relative to spacecraft trajectory .

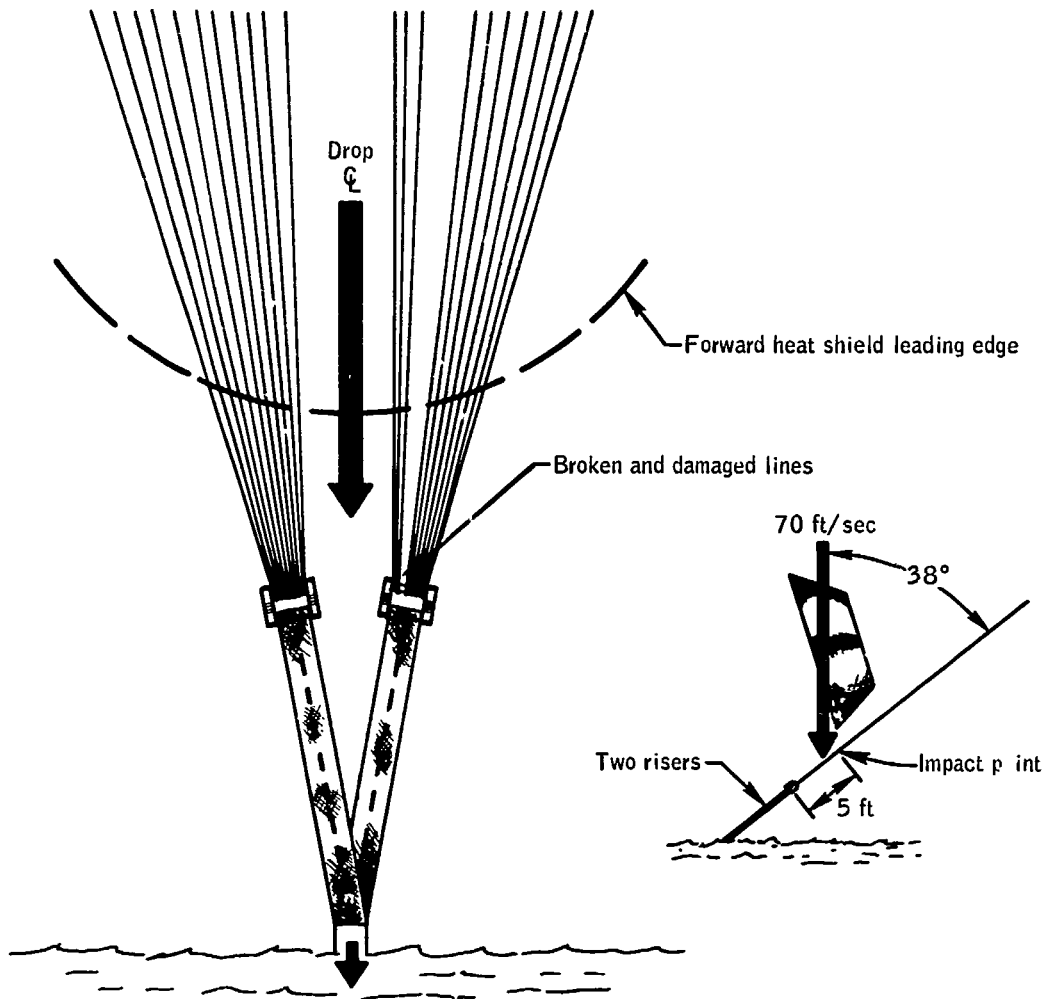
Figure 11.- Results of forward heat shield/suspension system impact test.

These tests showed that the forward heat shield contacting the parachute could damage some of the suspension lines, but would probably not cause a loss of riser legs.

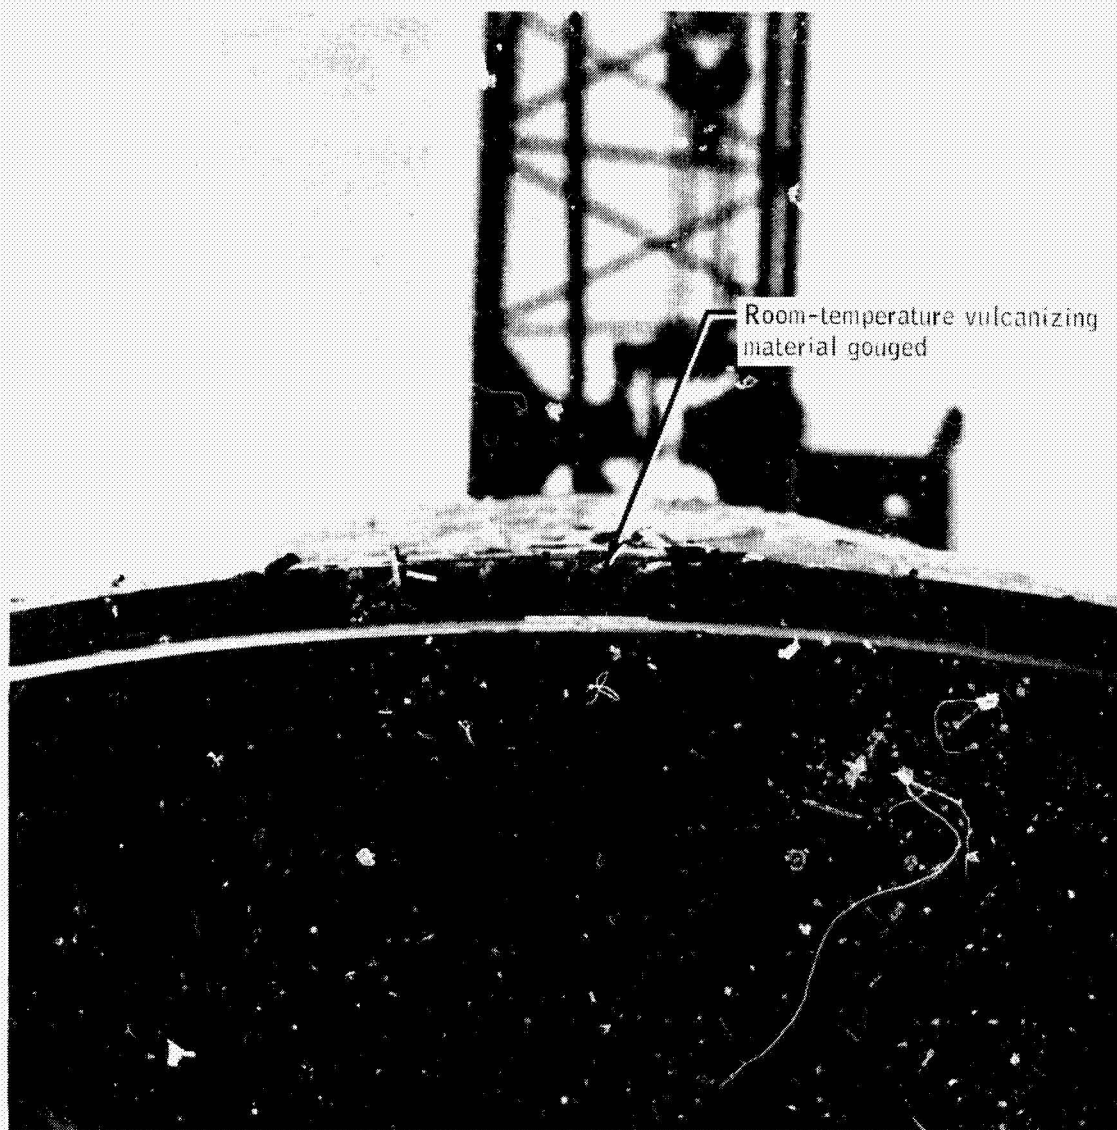
Figure 12.- Forward heat shield damage.

Forward heat shield/command module impact tests.- Using the suspension line/riser test setup, two additional drop tests with the forward heat shield impacting the spacecraft were performed. In the first test, the forward heat shield impacted the spacecraft upper deck in the minus Y and minus Z bays, causing very light surface damage to the spacecraft, but severe damage to the forward heat shield. In the second test, the forward heat shield impacted the spacecraft near the hatch, breaking the outer hatch window and gouging the ablator. Again, the forward heat shield was severely damaged.
